Improving the Performance of Solar PV Installations in Rural Locations in Nigeria: A Case Study

A study of solar PV installations in two rural settlements, Ide Village and Sagbokoji Village was undertaken

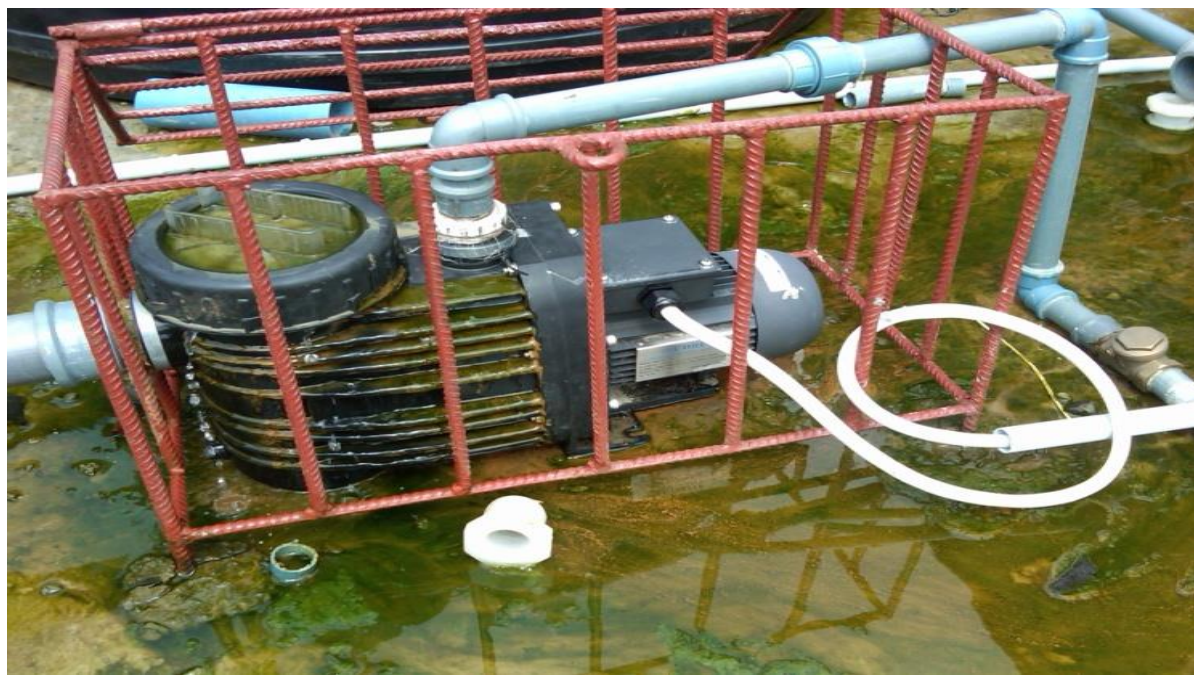
- The installation developed faults less than 3 months after it was installed
- No member of the community was trained by the installers on how to carry out (minor) repairs on the installation.
- Slow response by supervising agency to cases of faults.
- Palpable bitterness among the dwellers based on alleged bias relating to a 'bigger' solar PV installation to a relatively smaller neighbouring community
- Users are ignorant of 'transfer of ownership'; opined ownership of installation remains with the government
- No local security is provided for the installation, yet no case of sabotage is recorded
- Residents suggested means of improving the performance of the installation

Leaking surface water pump of the solar PV installation at Ide Village

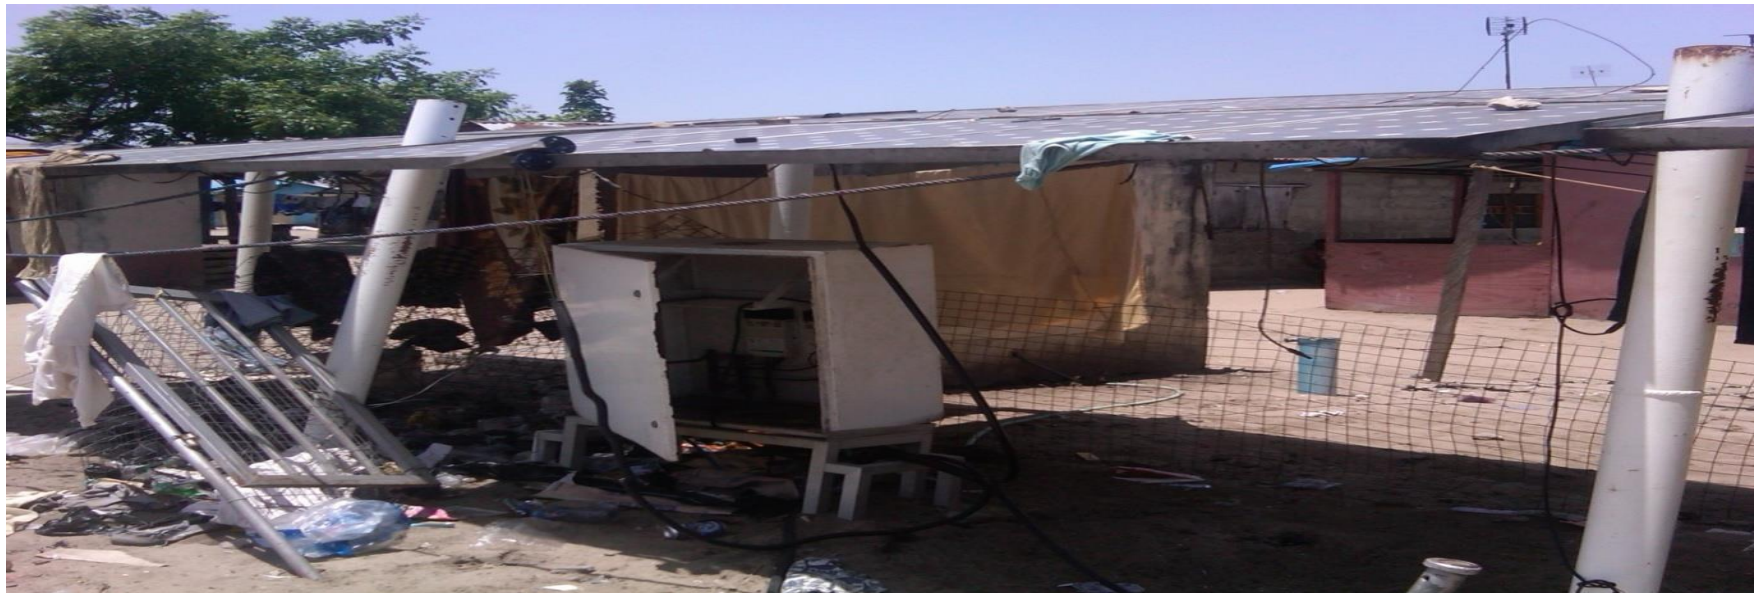
- The installation - the first of its type in Lagos State - was designed to power streetlights, lighting of village hall and to pump water.
- It started having problems less than 6 months after installation
- Initially, the supervising agency repaired the faults and restored the installation to its working state. However, the breakdown did not cease
- Users were alleged to have overloaded the system through illegal connections.
- After some time, supervising agency ceased to repair the installation
- Extensive breakdown period resulted in the community to slacken/ withdraw security provided for the installation
- Slackened security led to the installation to be vandalised by unknown persons; leading its present dilapidated state
- The situation has remained same for over 4 years and the probability of restoring it appears low

The non-functional Solar PV Installation Sagbokoji Village
